**Flood Control Project Maintenance
Levee Inspections**

Fall 2016 Levee Maintenance Deficiency Summary Report

Sacramento River Basin

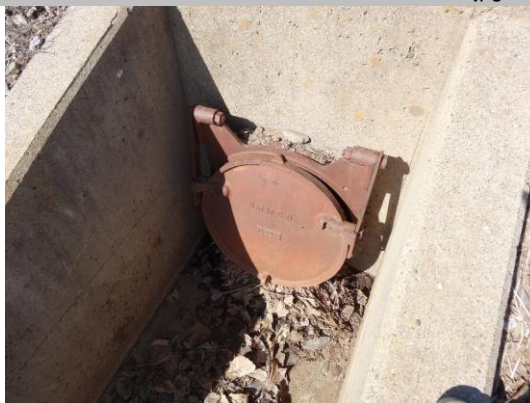
Photo 2 of 2 : UCIP_FA_2016_32044_58542.jpg

WS view: vegetation debris blocking outlet.

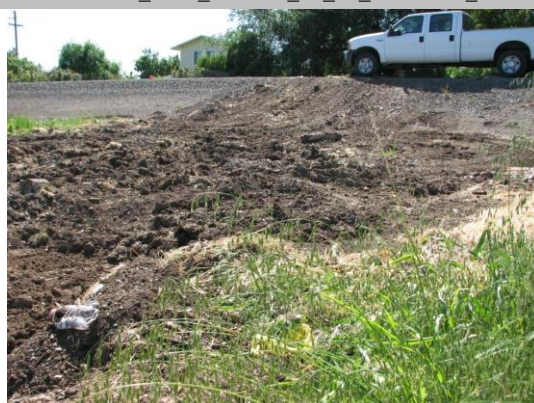
Photo 1 of 2 : FA_2016_NA0003_64_41_20160823_00025.jpg

04/25/2016: Soil and debris dragged across levee from L/S to W/S.

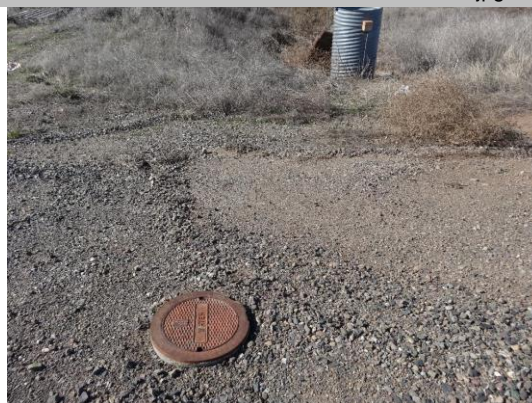
Photo 1 of 2 : UCIP_FA_2016_30291_55700.jpg

Comment Code					
Inspector Comment					
FS_ID:30291 DS_ID:19230 EP_NO: 16633 Repair Type: Non-Urgent Crossing Status: Indicator Found UCIP Comments: A concrete water control box on landside shoulder.It needs confirmation and more info from LMA and/or DWR Inspector. FIELD_STRUCT_DESC: A 2-inch diameter storm water discharge pipeline through the right bank and landward levee toe of Mud Creek. Used a 2-inch coated & wrapped steel pipe. Submerged pump in 36 inch dia CMP casing approx 10 ft from landside toe. Drainage ditch, up to 4 ft wide, runs perpendicular to levee alignment starting at CMP riser and running away from levee. (App. No. 16633) FS Date: 2/20/2014

LS view: CMP riser on levee toe (top) and control box on levee shoulder (bottom).

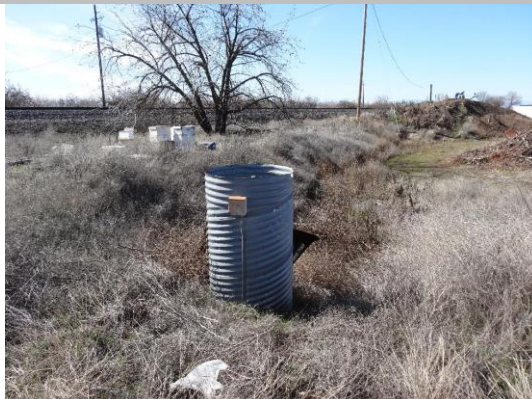
Photo 2 of 2 : UCIP_FA_2016_30291_55699.jpg

LS view: CMP riser on levee toe and drainage ditch perpendicular to the levee.

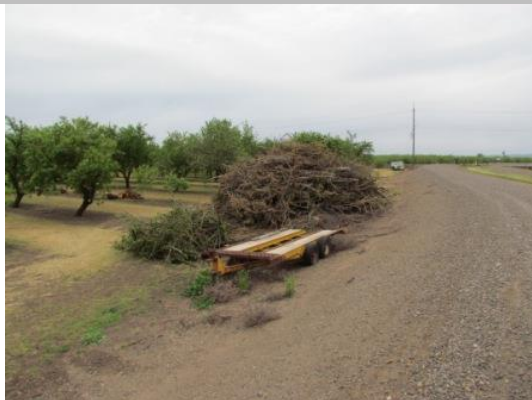
Photo 1 of 1 : FA_2016_NA0003_64_1_20160823_00001.jpg

LM Start	2.93	Rating **	M	Issue No.	1
LM End	2.93	Issue Type +	En	Location *	LS
Category	Earthen Levee			GPS Latitude/Longitude	
				Start	End
Item	Encroachments			39.759755 °	39.759755 °
				-121.911160 °	-121.911160 °
DWR ID	DWR_NA0003_01_s_2012_1				
Comment Code					
PR : Prunings					
Inspector Comment					
Remove the prunings from the landside slope.

View of the pruning pile along the landside toe.

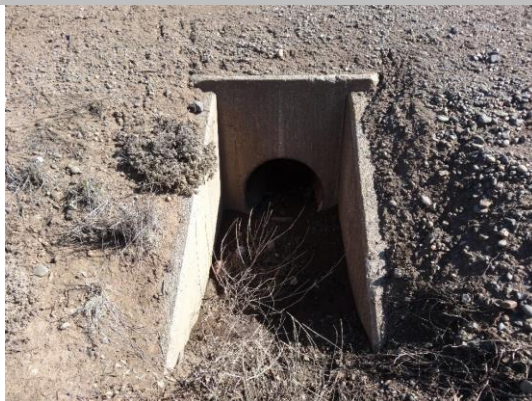
Photo 2 of 2 : UCIP_FA_2016_30294_55703.jpg

FS_ID:30294
DS_ID:19216
EP_NO: N/A
Repair Type: Non-Urgent
Crossing Status: Found
UCIP Comments: Inlet and outlet needs cleaning and clearing of debris.
FIELD_STRUCT_DESC: 24-inch CM pipe through levee, 8.5 feet below the crown. Flap gate on the waterward end. Concrete "U" headwalls on both ends. Grouted riprap apron on the landward end. Grouted riprap spillway on the waterward end. O&M Manual Sac 504, May 1965.
FS Date: 2/20/2014

LS view: U type concrete headwall and CMP on levee slope. Debris blocking the inlet pipe.

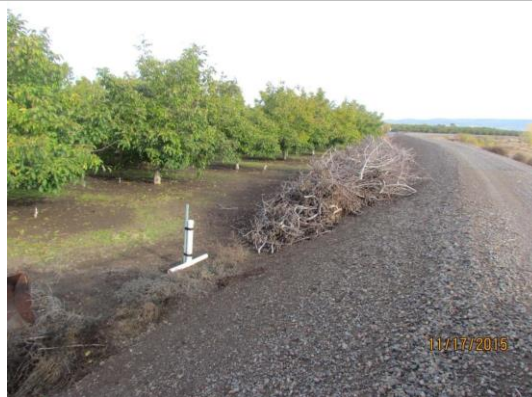
Photo 2 of 2 : FA_2016_NA0003_64_31_20160823_00016.jpg

View of the prunings and bait station along the landside slope.

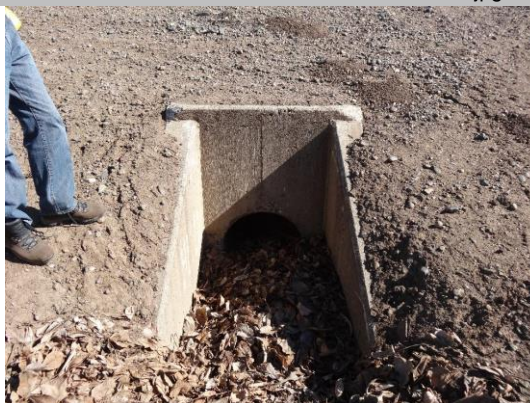
Photo 2 of 2 : UCIP_FA_2016_30295_55705.jpg

LS view: U type concrete headwall and CMP on levee slope. Vegetation debris blocking the inlet.

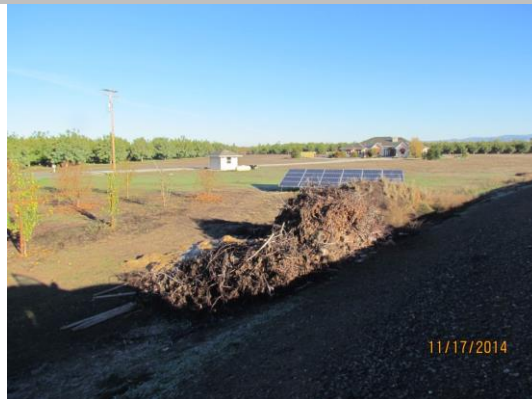
Photo 1 of 1 : FA_2016_NA0003_64_27_20160823_00011.jpg

View of the prunings along the landside toe.

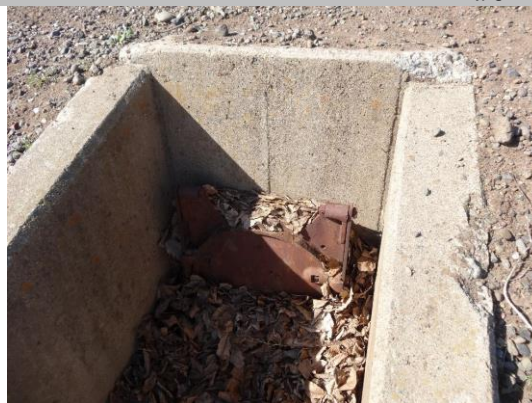
Photo 1 of 2 : UCIP_FA_2016_30310_55741.jpg

WS view: U type concrete headwall, pipe, and flapgate on levee slope.
Vegetation debris blocking outlet.

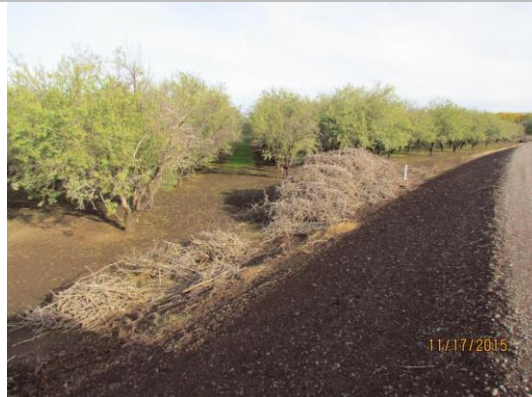
Photo 1 of 1 : FA_2016_NA0003_64_32_20160823_00017.jpg

View of the prunings along the landside toe.

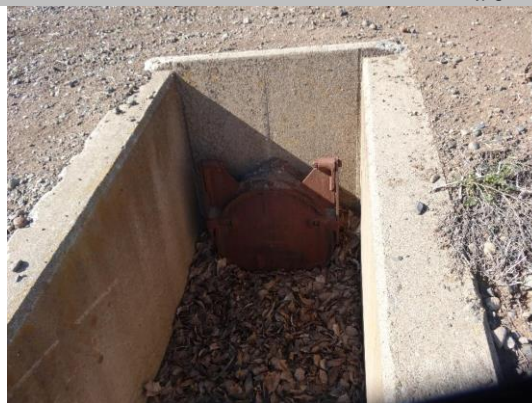
Photo 1 of 2 : UCIP_FA_2016_30311_55743.jpg

WS view: U type concrete headwall, pipe, and flapgate on levee slope. Vegetation debris blocking outlet.

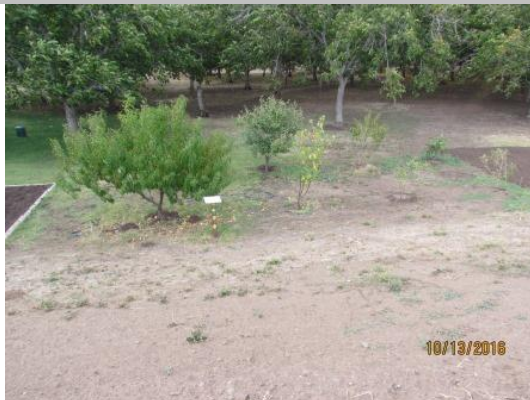
Photo 1 of 1 : FA_2016_NA0003_64_29_20161019_00058.jpg

View of the fruit trees within 10' of landside levee toe.

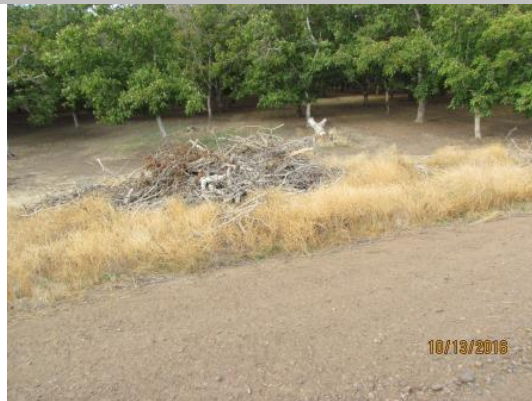
Photo 1 of 1 : FA_2016_NA0003_64_52_20161019_00060.jpg

View of the prunings along the landside toe.

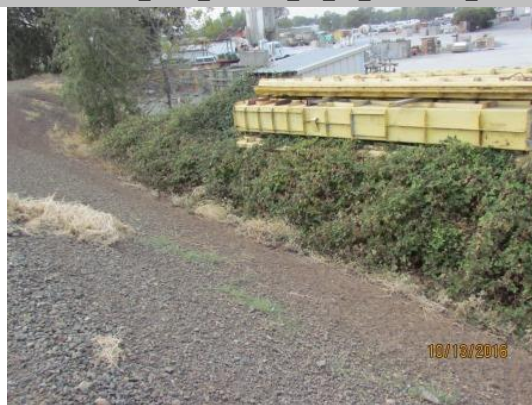
Photo 1 of 1 : FA_2016_NA0003_64_55_20161019_00062.jpg

View of the blackberries blocking visibility and access.

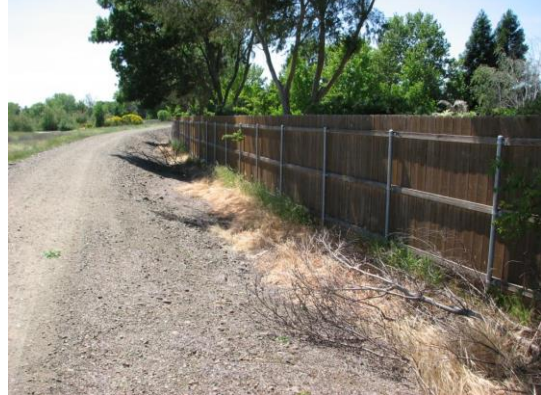
Photo 1 of 1 : FA_2016_NA0003_64_28_20160823_00012.jpg

View of the fence blocking visibility and access along the landside toe.

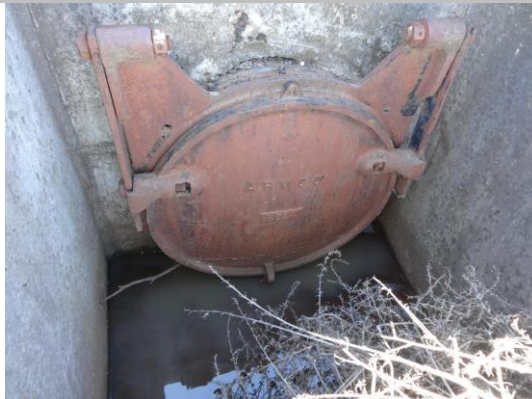
Photo 2 of 2 : UCIP_FA_2016_31667_57967.jpg

WS view: U type concrete headwall, pipe, and flapgate on levee slope. Vegetation debris on outlet box.

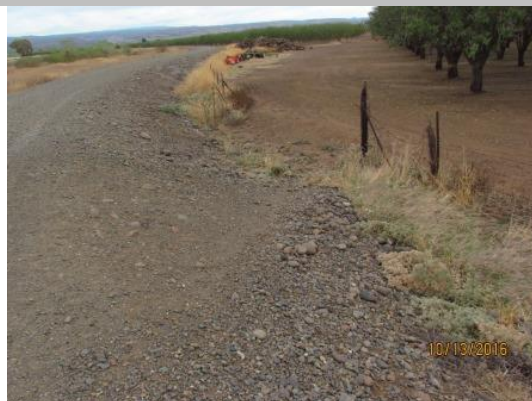
Photo 1 of 1 : FA_2016_NA0003_65_29_20161019_00015.jpg

View of the slope instability caused by vehicles along the landside slope.

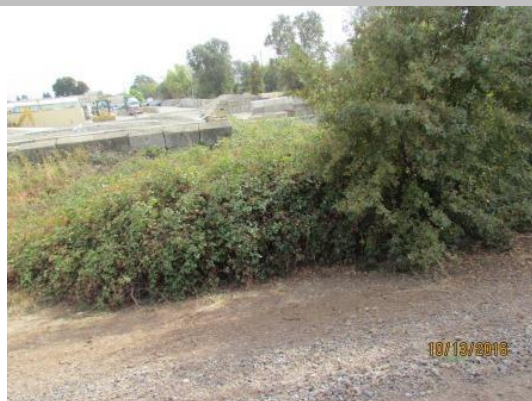
Photo 1 of 1 : FA_2016_NA0003_65_30_20161019_00016.jpg

View of the blackberries blocking visibility and access.

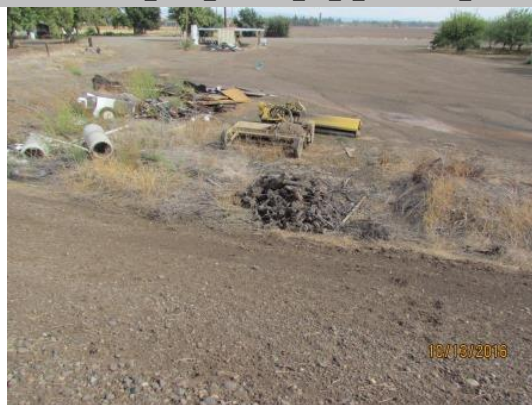
Photo 1 of 1 : FA_2016_NA0003_65_1_20161019_00018.jpg

View of the firewood and broken concrete pipes along the landside toe.

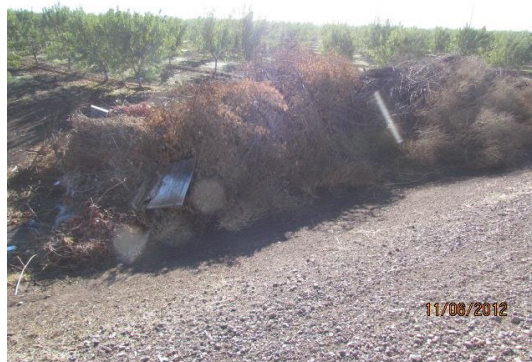
Photo 1 of 1 : FA_2016_NA0003_65_5_20160823_00003.jpg

View of the brush pile along landside toe.

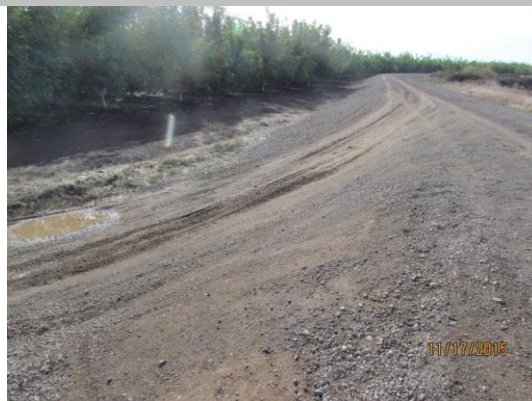
Photo 1 of 1 : FA_2016_NA0003_65_10_20160823_00006.jpg

View of the vehicle erosion along the landside slope.

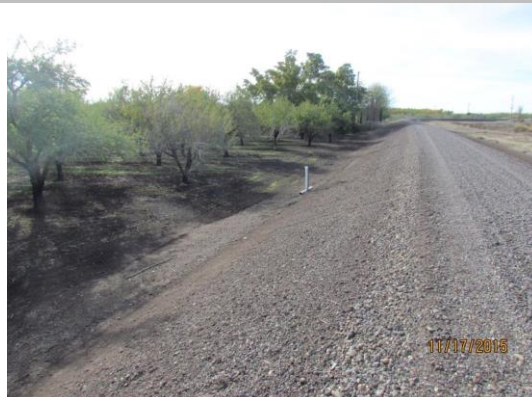
Photo 2 of 2 : FA_2016_NA0003_65_8_20160823_00005.jpg

View of the bait station by the rodent holes.

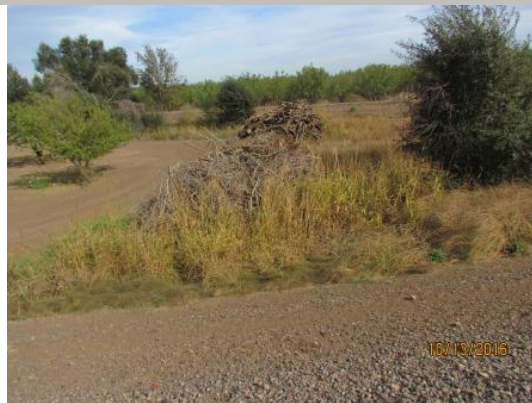
Photo 1 of 1 : FA_2016_NA0003_65_35_20161019_00021.jpg

View of the prunings along the landside toe.

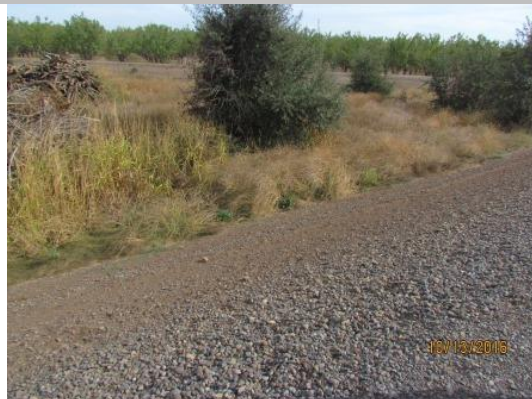
Photo 1 of 1 : FA_2016_NA0003_65_36_20161019_00022.jpg

View of the dense vegetation along the landside toe.

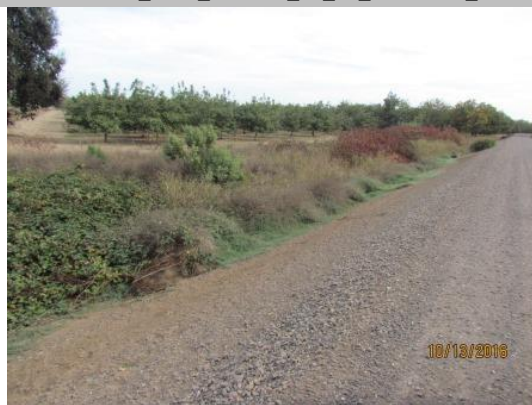
Photo 1 of 1 : FA_2016_NA0003_65_40_20161019_00027.jpg

View of the dense vegetation along the landside toe blocking visibility and access.

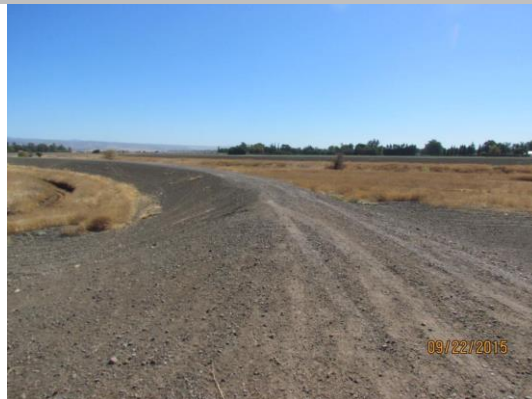
Photo 1 of 1 : FA_2016_NA0003_67_12_20160823_00002.jpg

View of the erosion on both slopes caused by motorcycle traffic.

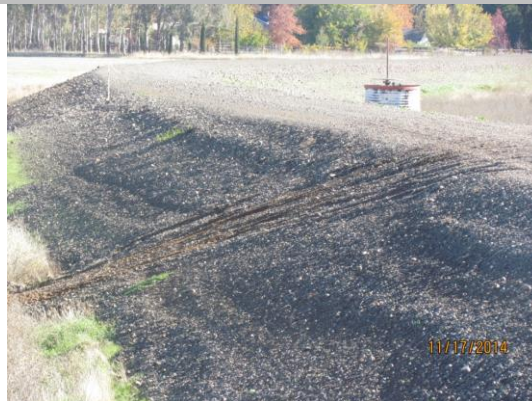
Photo 1 of 1 : FA_2016_NA0003_67_3_20160823_00001.jpg

View of the erosion caused by motorcycles on the land side slope.

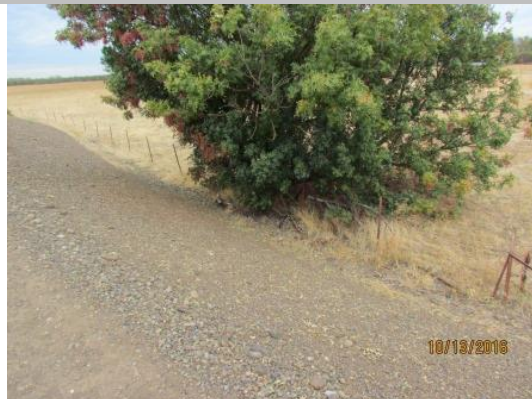
Photo 1 of 1 : FA_2016_NA0003_67_15_20161019_00022.jpg

View of the overgrown tree along the landside slope.

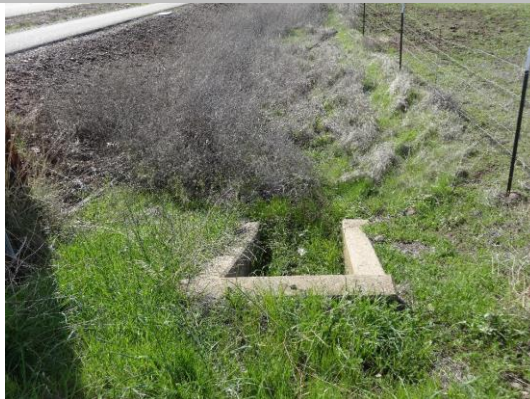
Photo 2 of 2 : UCIP_FA_2016_32124_58624.jpg

LS view: U type concrete headwall of CMP culvert on levee slope.
Vegetation on inlet box.

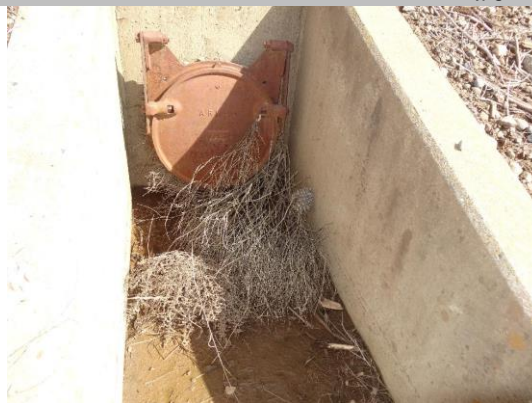
Photo 1 of 2 : UCIP_FA_2016_31901_58194.jpg

WS view: U type concrete headwall, flapgate, and CMP on levee slope.
Needs cleaning and clearing.

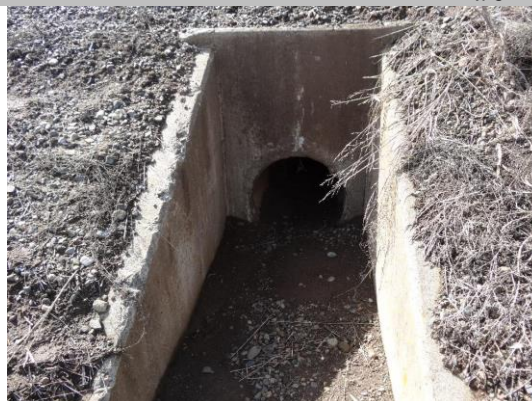
Photo 2 of 2 : UCIP_FA_2016_31901_58193.jpg

LS view: U type concrete headwall and CMP on levee slope. Soil/mud on inlet box.

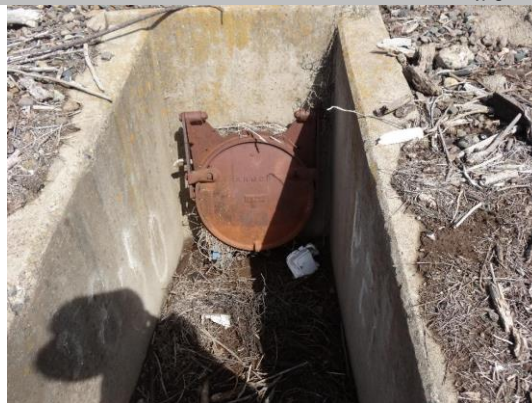
Photo 1 of 2 : UCIP_FA_2016_31864_58069.jpg

WS view: U type concrete headwall, pipe, and flapgate on levee slope. Soil/mud on outlet box. Vegetation debris blocking outlet box.

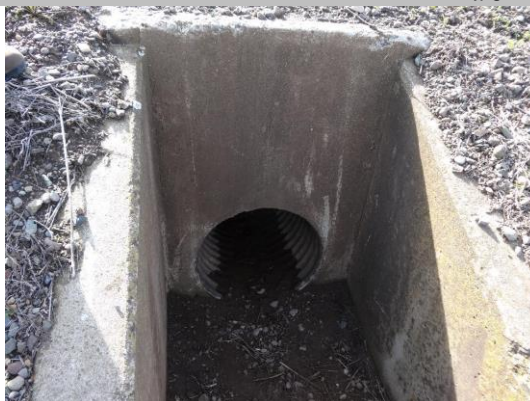
Photo 2 of 2 : UCIP_FA_2016_31864_58068.jpg

LS view: U type concrete headwall and CMP on levee slope. Soil/mud on inlet box.

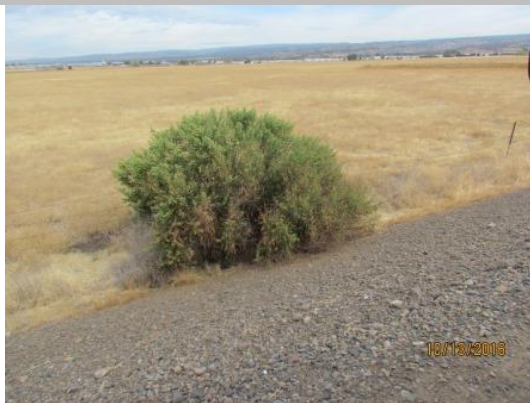
Photo 1 of 1 : FA_2016_NA0003_67_14_20161019_00023.jpg

View of a bush along the landside toe.

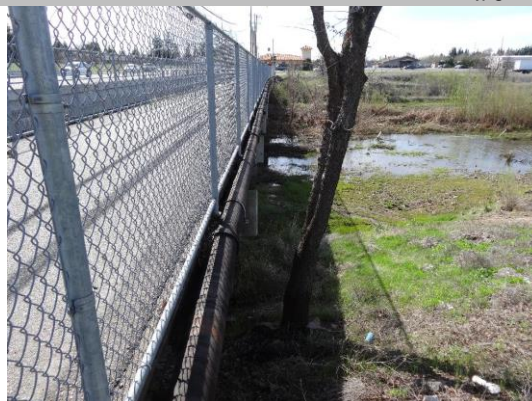
Photo 1 of 1 : UCIP_FA_2016_31851_58041.jpg

WS view: 6-inch steel pipe attached to Cohasset Road Bridge. Needs confirmation from LMA whether this is a gasoline.

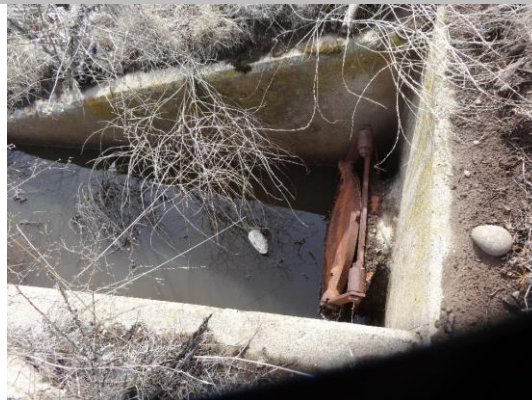
Photo 1 of 2 : UCIP_FA_2016_32125_58629.jpg

WS view: U type concrete headwall, pipe, and flapgate on levee slope. Soil/mud on outlet box. Vegetation debris blocking outlet box.

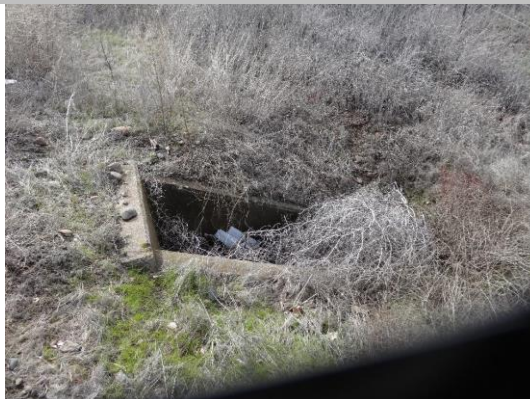
Photo 2 of 2 : UCIP_FA_2016_32125_58628.jpg

LS view: U type concrete headwall and pipe on levee slope. Soil/mud on inlet box. Vegetation debris blocking inlet box.

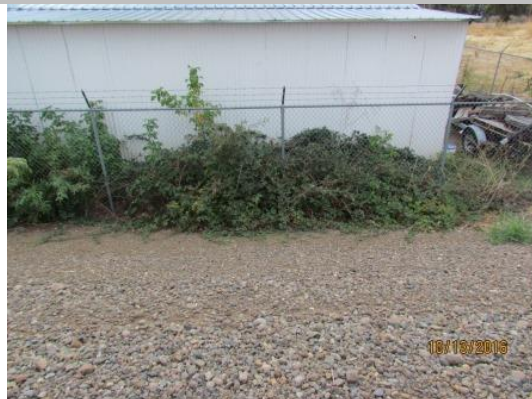
Photo 1 of 1 : FA_2016_NA0003_68_20_20161019_00036.jpg

View of the vegetation along the landside toe blocking visibility.

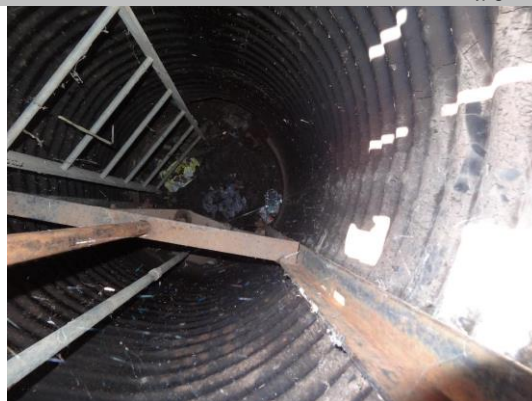
Photo 2 of 2 : UCIP_FA_2016_32025_58511.jpg

WS view: inside view of slide gate in CMP riser on waterside shoulder. Debris trapped in the riser.

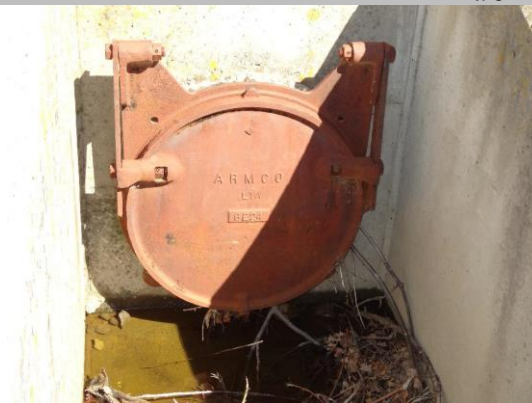
Photo 1 of 2 : UCIP_FA_2016_32023_58505.jpg

WS view: U type concrete headwall and CMP on levee slope. Vegetation debris and mud on outlet box. Needs cleaning and clearing.

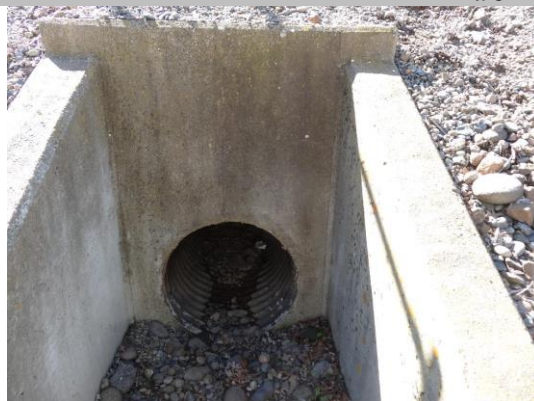
Photo 2 of 2 : UCIP_FA_2016_32023_58504.jpg

LS view: U type concrete headwall and CMP on levee slope. Pebbles and mud on inlet box.

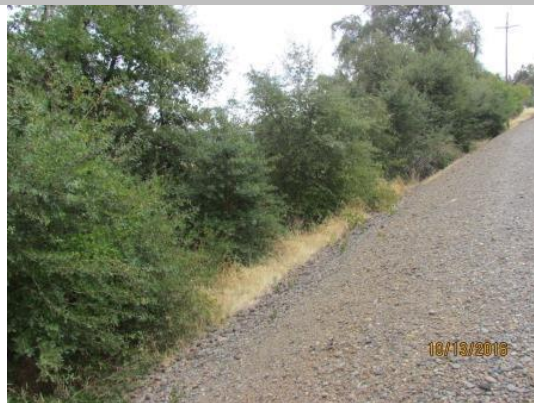
Photo 1 of 1 : FA_2016_NA0003_68_21_20161019_00037.jpg

View of the overgrown trees along the landside toe.

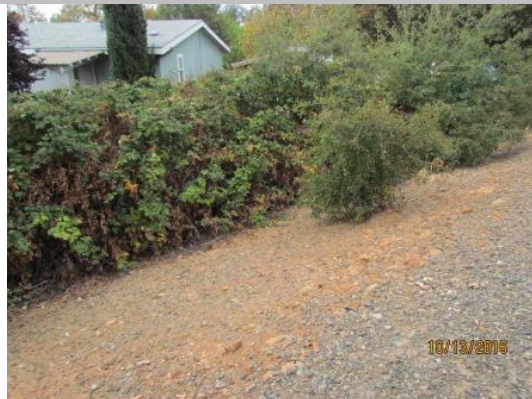
Photo 1 of 1 : FA_2016_NA0003_68_22_20161019_00038.jpg

View of the blackberries blocking visibility and access.

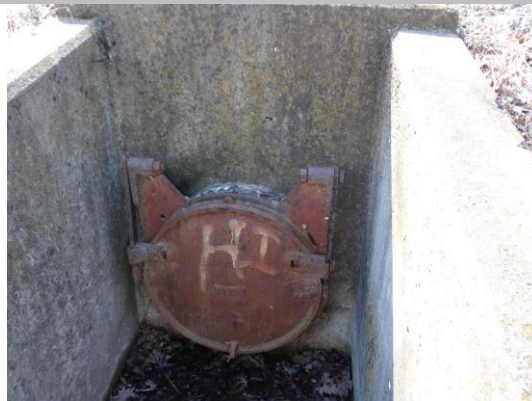
Photo 1 of 2 : UCIP_FA_2016_32143_58641.jpg

WS view: U type concrete headwall and CMP on levee slope. Soil/mud on outlet box. Needs cleaning and clearing.

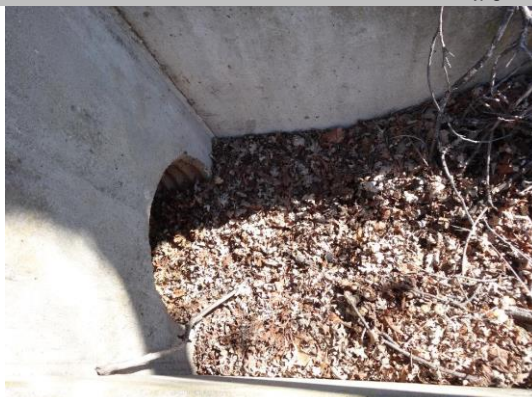
Photo 2 of 2 : UCIP_FA_2016_32143_58640.jpg

LS view: U type concrete headwall and CMP on levee slope. Vegetation and mud on inlet box.

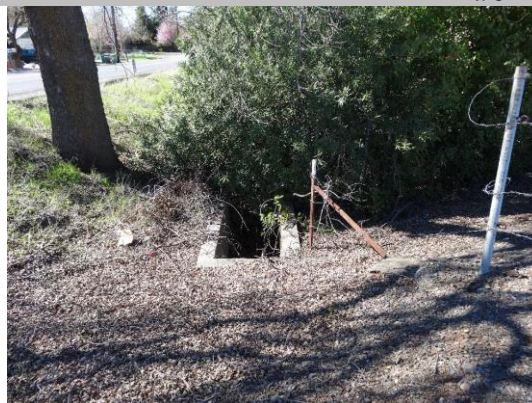
Photo 1 of 2 : UCIP_FA_2016_32144_58644.jpg

LS view: U type concrete headwall of CMP culvert on levee slope. Vegetation debris and mud on inlet box.

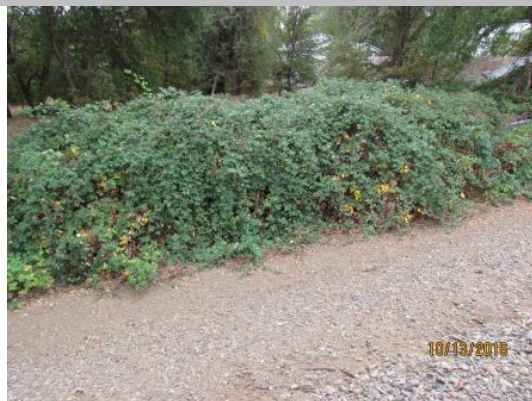
Photo 1 of 1 : FA_2016_NA0003_68_23_20161019_00039.jpg

View of the blackberries blocking visibility and access.

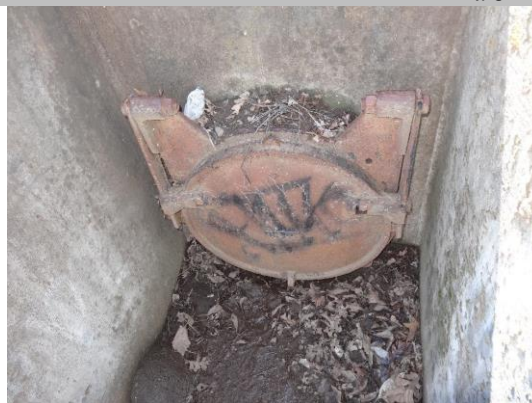
Photo 1 of 2 : UCIP_FA_2016_31963_58384.jpg

WS view: U type concrete headwall and CMP on levee slope. Vegetation debris and mud on outlet box. Needs cleaning and clearing.

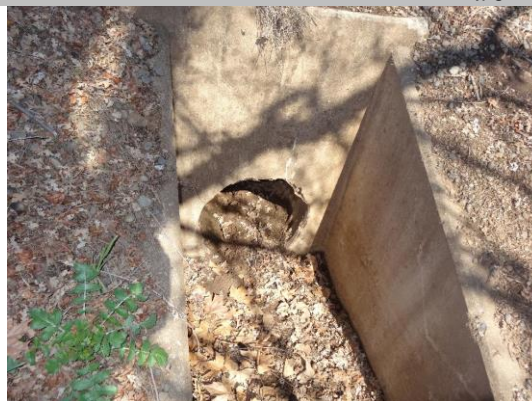
Photo 2 of 2 : UCIP_FA_2016_31963_58383.jpg

LS view: U type concrete headwall and CMP on levee slope. Vegetation debris and mud on inlet box.

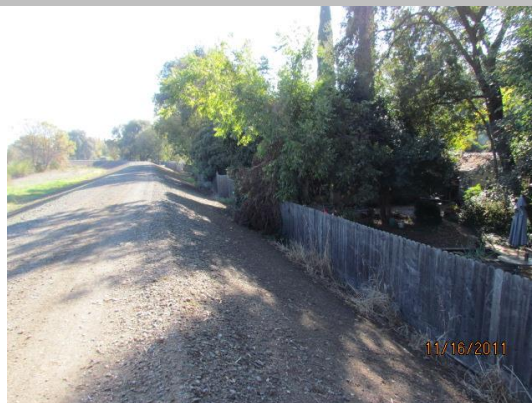
Photo 1 of 1 : FA_2016_NA0003_68_3_20160823_00003.jpg

View of the fence along the landside toe.

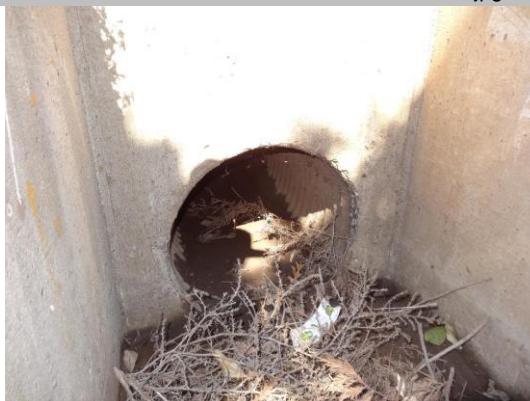
Photo 2 of 2 : UCIP_FA_2016_31964_58388.jpg

LS view: U type concrete headwall and CMP on levee slope. Vegetation debris and mud in inlet box.

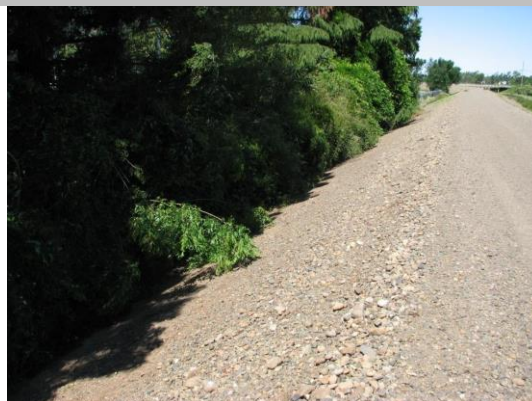
Photo 1 of 1 : FA_2016_NA0003_68_18_20160823_00005.jpg

View of the vegetation on fence at landside toe.

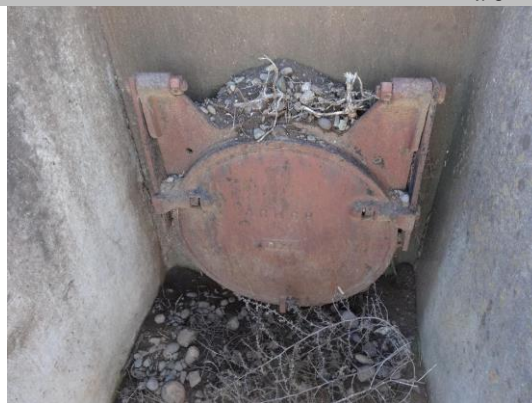
Photo 1 of 2 : UCIP_FA_2016_31965_58395.jpg

WS view: U type concrete headwall and CMP on levee slope. Vegetation debris and mud in outlet box. Needs cleaning and clearing.

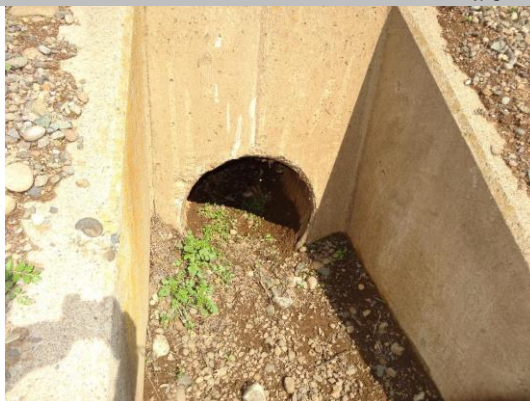
Photo 2 of 2 : UCIP_FA_2016_31965_58394.jpg

LS view: U type concrete headwall and CMP on levee slope. Vegetation debris and mud in inlet box.

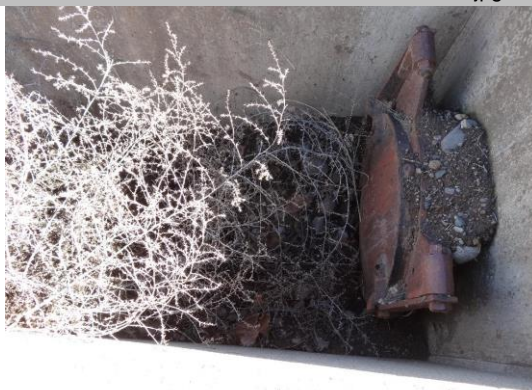
Photo 2 of 2 : UCIP_FA_2016_31966_58400.jpg

WS view: U type concrete headwall and CMP on levee slope. Vegetation debris and mud on outlet box. Needs cleaning and clearing.

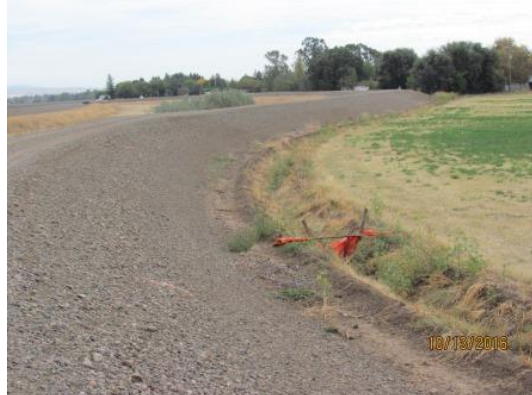
Photo 1 of 1 : FA_2016_NA0003_68_24_20161019_00040.jpg

View of a ditch along the landside toe.

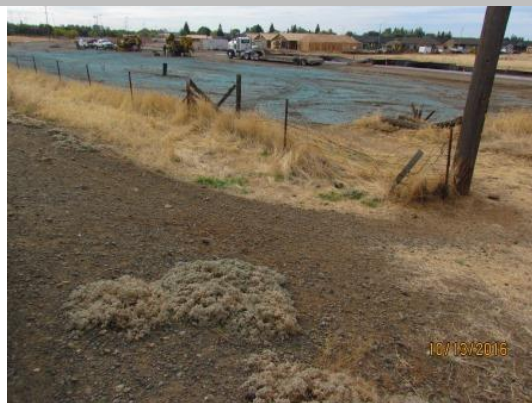
Photo 1 of 1 : FA_2016_NA0003_69_13_20161019_00014.jpg

View of the damaged slope by foot traffic.
